## Weather Notes

### SEVERE HAIL, SELDEN, KANSAS, JUNE 3, 1959

A. D. ROBB

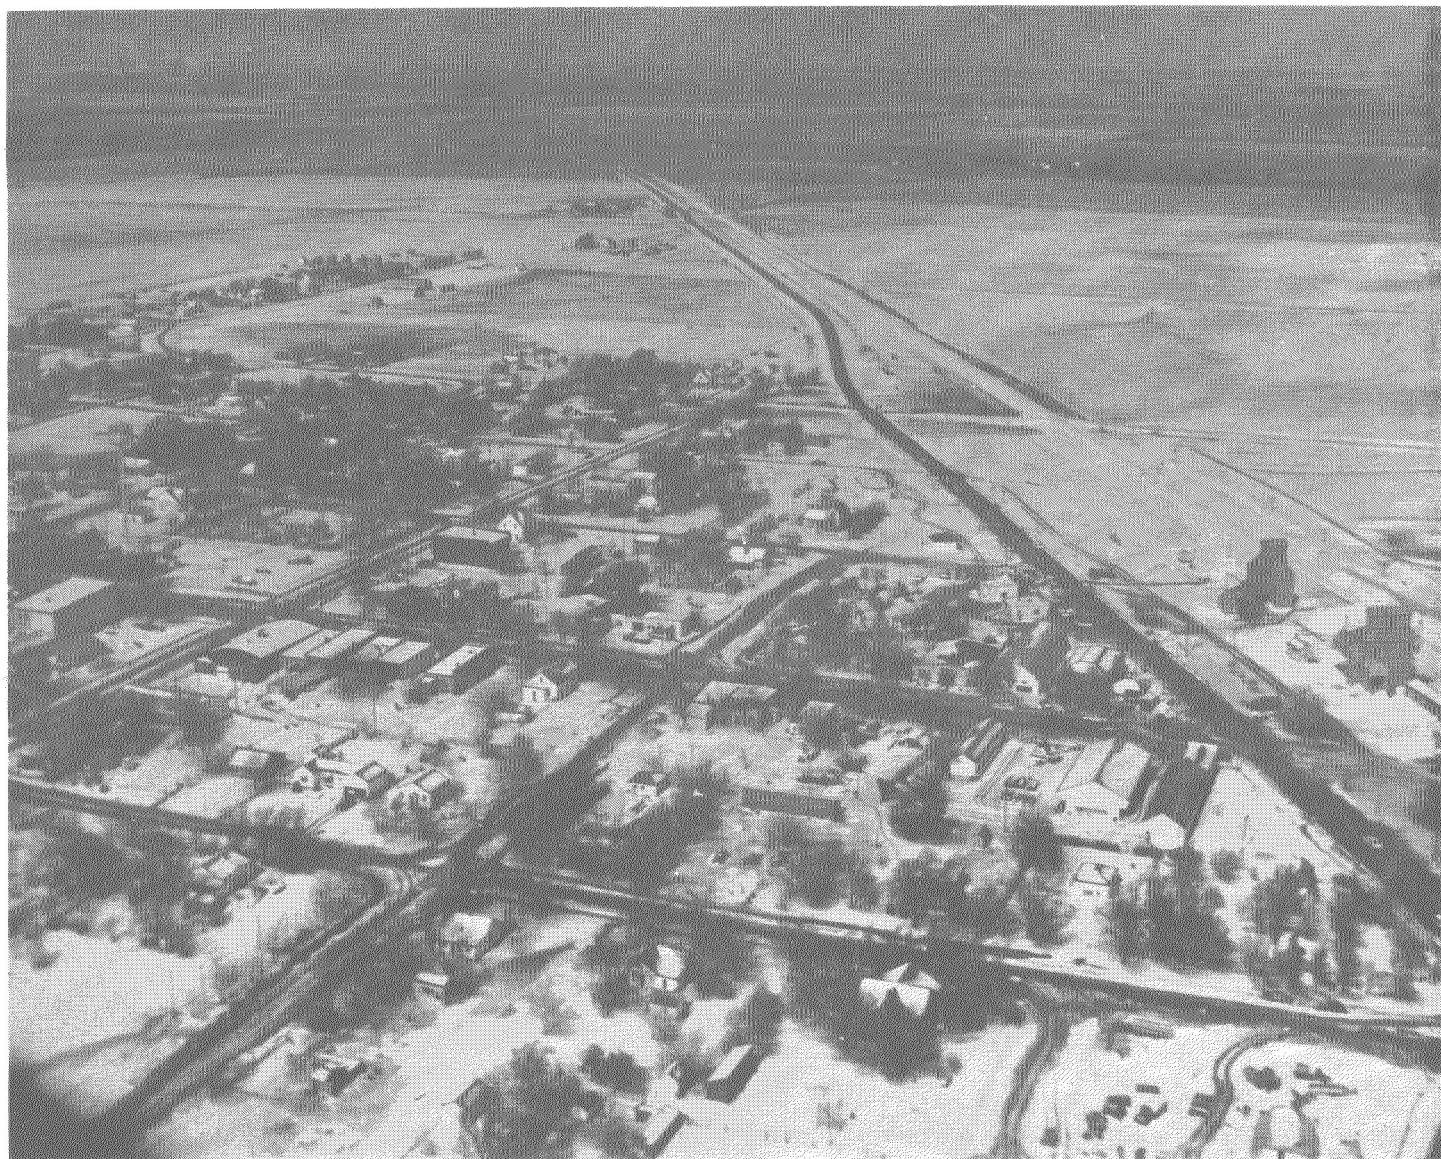
FIGURE 1.—Aerial view showing 18 inches of hail covering Selden, Kans. on June 3, 1959. Outline of fields can be seen in distance, which shows the extent of the hail southwest of Selden. (Photo courtesy *Norton Daily Telegram*.)

The hail accumulated to a depth of 18 inches and was mostly pea or marble size and many of the stones were soft. Drifts were 3 to 4 feet deep at the sides of buildings where it fell from the roofs. Piles along the streets and roads remained for 2 days. Traffic on U.S. Highway 83 was halted, and approximately 100 automobiles were stalled 4 hours, or more, until bulldozers could open the roads. Snow plows were unable to move the weight.

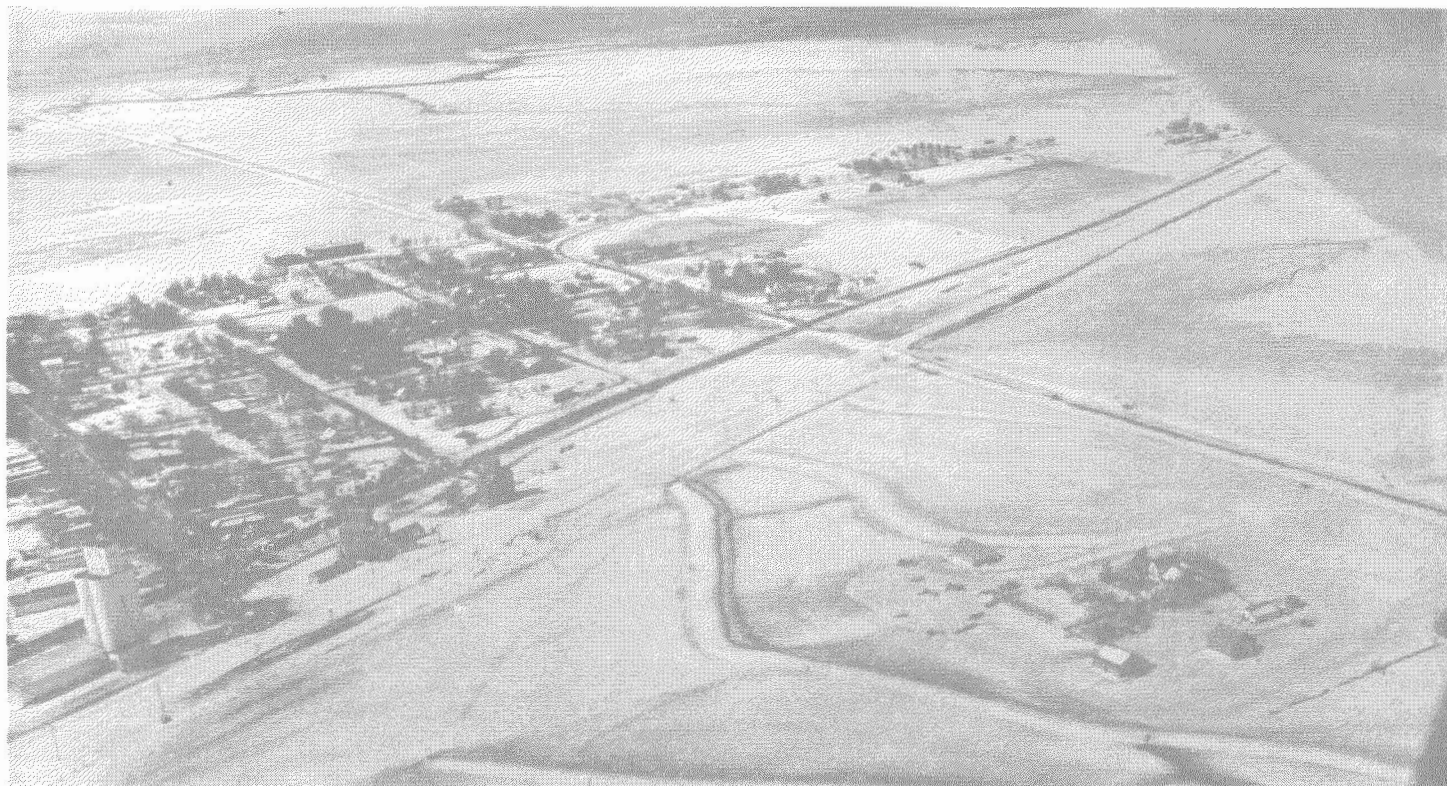
FIGURE 2.—Aerial view of Selden and vicinity, June 3, 1959. Southern edge of hail area is shown at top of picture. (Photo courtesy Norton Daily Telegram.)

The area covered by the hail was elongated, about 9 miles northeast to southwest and 6 miles across at the widest. Selden was located a little to the northeast of the center of the area.

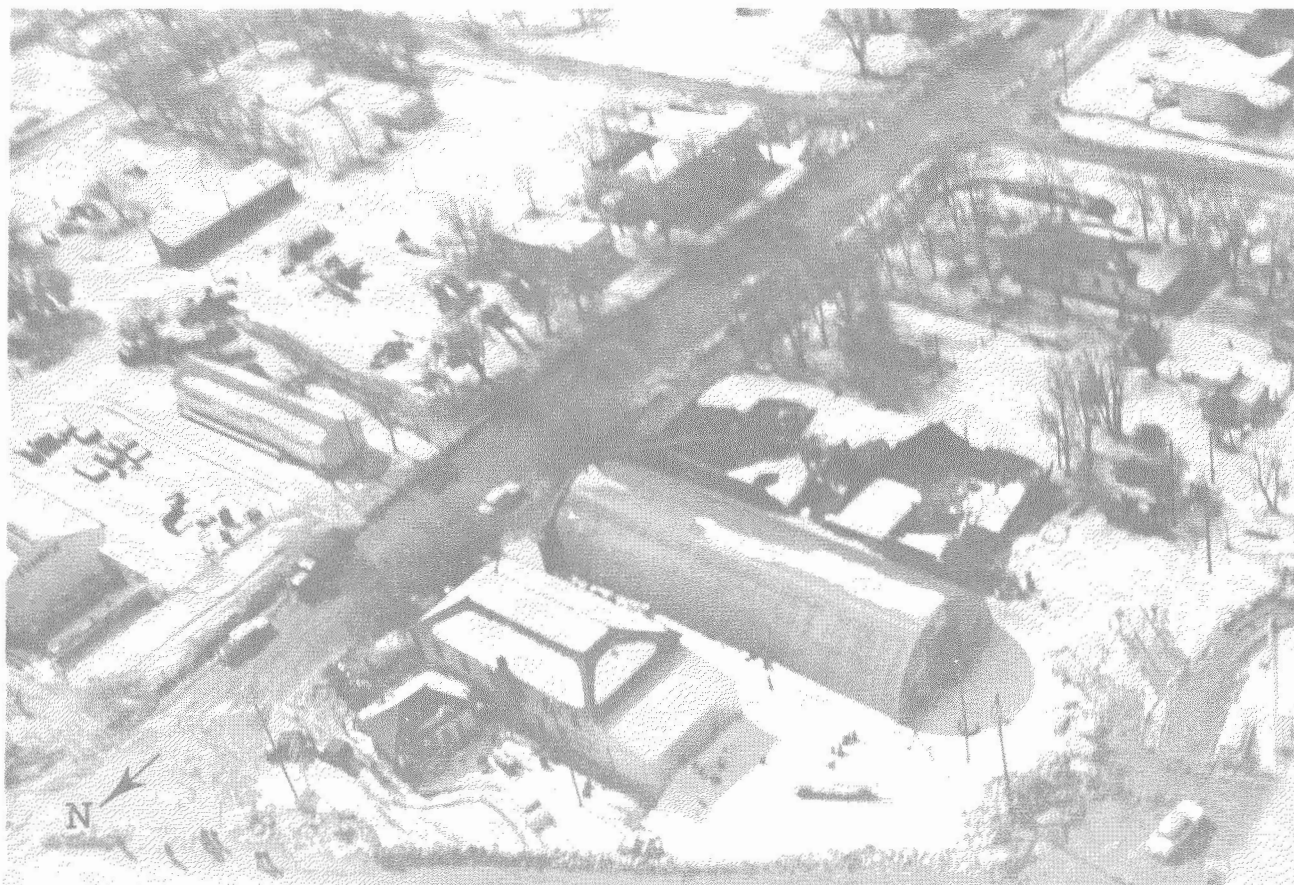
FIGURE 3.—Aerial close-up of Selden, June 3, 1959, shows how trees were stripped of leaves and flat roofs were caved in. Black area of building next to the quonset is collapsed part of roof. (Photo courtesy Norton Daily Telegram.)

The Red Cross reported 2 business buildings destroyed, major damage done to 10 business houses, 8 farm buildings, and 5 homes. Minor damage was indicated to almost every building in the area, 154 homes, 125 farm buildings, and 27 business buildings. In some measure the damage was due to the continuous pelting of the stones but the greater losses resulted from the tremendous weight

of accumulated hail on flat- or nearly flat-roofed buildings, causing them to collapse. The hail accumulation on a truck scale, 10 x 45 feet, weighed 28,000 pounds, or 62.2 pounds per square foot. Damage over the area was estimated at \$500,000.

Trees were stripped of leaves and small branches, and with the ground hail-covered the town had much the appearance of winter. In just a few minutes the temperature on local thermometers dropped from near 80° to 38° during the storm.
